**Third Five-Year Review Report
for
Mottolo Pig Farm Superfund Site
Town of Raymond, Rockingham County, New Hampshire
August 2008**

Prepared by
Engineering/Planning Division
New England District
Concord, MA

Prepared for
United States Environmental Protection Agency
Region I-New England
Boston, Massachusetts

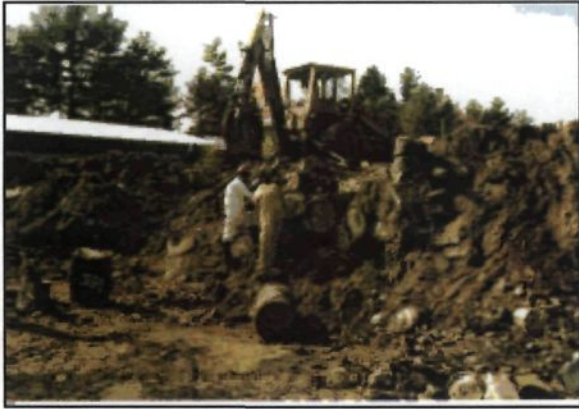
Figure 4. Photo of drum removal during 1981 excavation (USEPA, 2008).

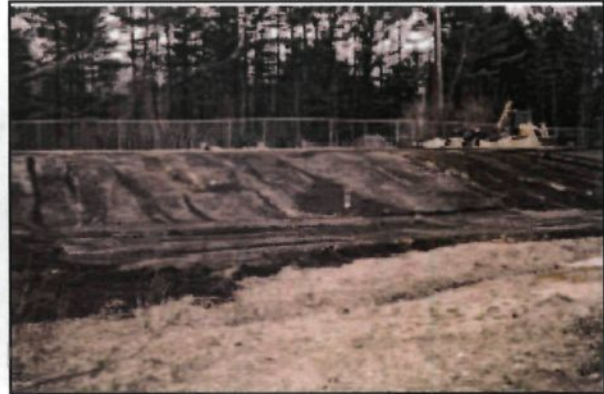
Figure 5. Soil removal and liner installation in 1997 (USEPA, 2008).

Based on results for soil and leachate samples, the extraction system was turned off in late 1996. All aboveground components of the system were removed from the treated area in December 1996, and a liner was installed to minimize infiltration of water in spring 1997 (Figure 5). The interceptor trench and liner were removed from the FDDA in December 2001 and the area was re-graded and seeded with grass.

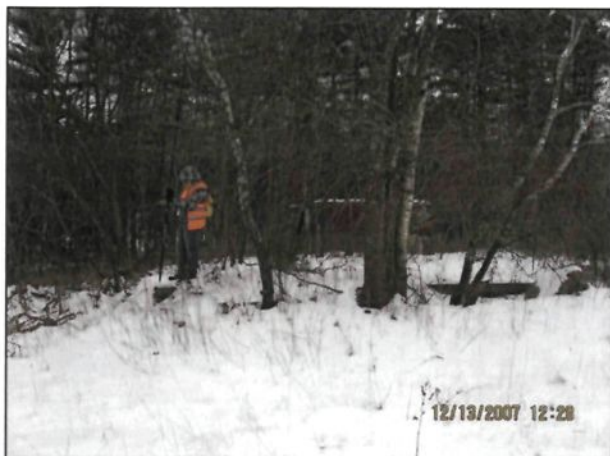
Figure 11 East end of former Piggery Building slab looking toward Brook A.

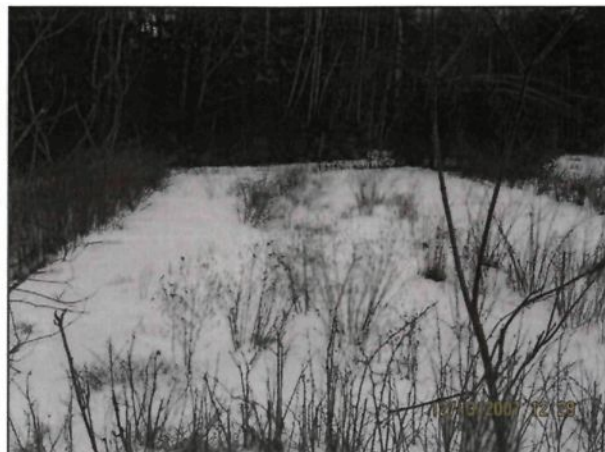
Figure 12. View across the slab used for drum staging by EPA in 1980-81.

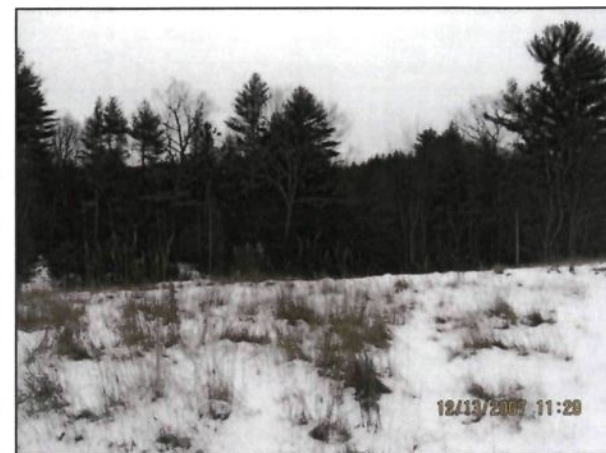
Figure 13. View across the fill within the remediated swale area.

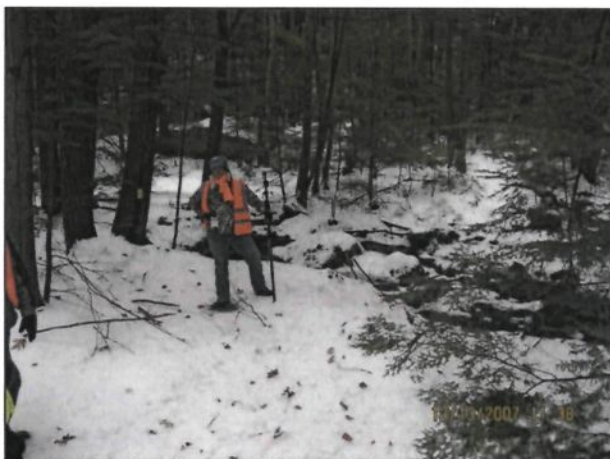
Figure 14. View of Brook A near the confluence of the drainage swale looking north.

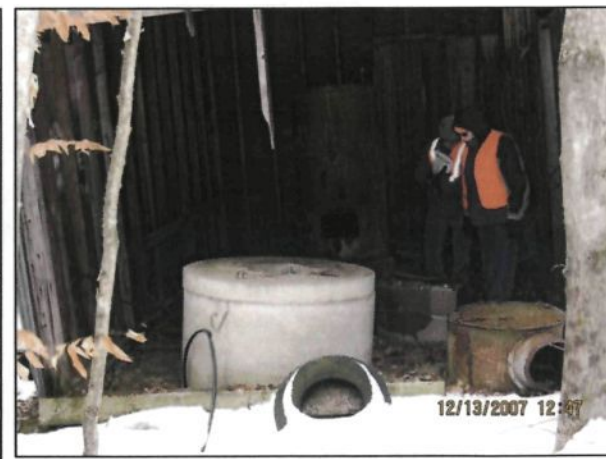
Figure 16. View of concrete structure covering the dug well and the boiler inside the Site's Well Shed.
